# Wood Destroying Pests and Organisms Inspection Report

Building No. <b>22676 SILVER OAK CT</b>	Street	City <b>Cupertino</b>	Zip <b>95014</b>	Date of Inspection <b>8/31/2009</b>	Number of Pages <b>8</b>
--------------------------------------------	--------	--------------------------	---------------------	----------------------------------------	-----------------------------

## MISNER TERMITE CONTROL

General Description: <b>THIS INSPECTION IS LIMITED TO THE INTERIOR ONLY                  CONDOMINIUM UNIT OF 22676 SILVER OAK CT CUPERTINO CA                  95014.</b>	Inspection Tag Posted: <p style="text-align: center;"><b>Garage</b></p> <hr/> Other Tags Posted: <p style="text-align: center;"><b>NO</b></p>
--------------------------------------------------------------------------------------------------------------------------------------------------------------------------------------	-----------------------------------------------------------------------------------------------------------------------------------------------------

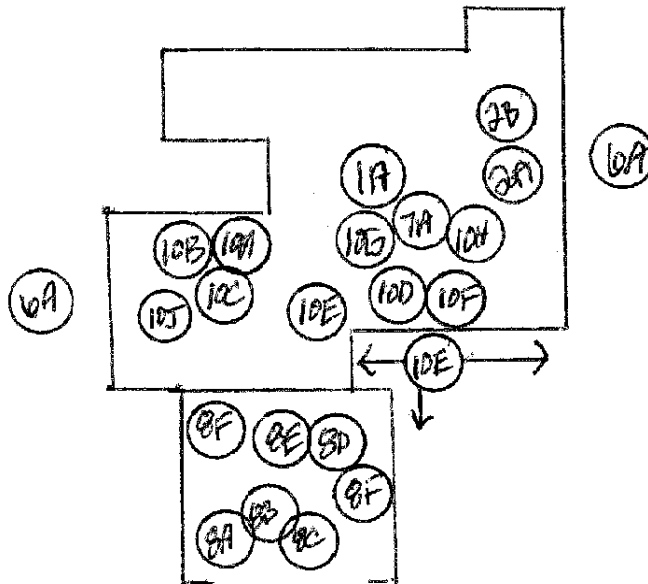
Diagram Not to Scale. Items Are In Approximate Location

**8C- FINDING:** Evidence of drywood termite fecal pellets were noted at the area indicated on the diagram..

**10C- FINDING:** Evidence of drywood termite fecal pellets were noted at the area indicated on the diagram..

**RECOMMENDATION :** Remove the fecal pellets with a vacume or mask over as needed. Note: Fecal pellets can sift down out of the wood over time due to vibrations and movement.
