CONFIDENTIAL INSPECTION REPORT

**909 BERKELEY AVENUE
MENLO PARK, CA**

INSPECTED ON:

March 24, 2009

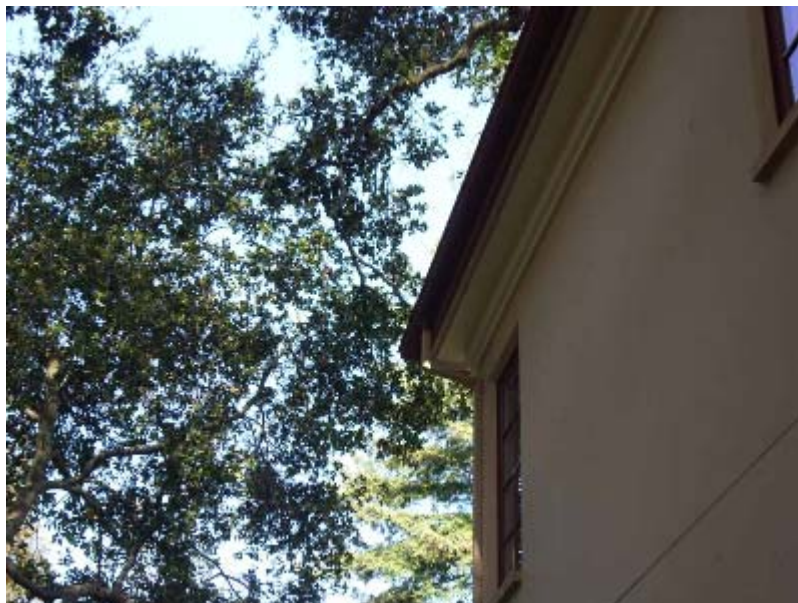
There are tree branches overhanging the roof in some areas. We recommend they be kept trimmed back to reduce the chance of damage to the roofing.

Overhanging branches

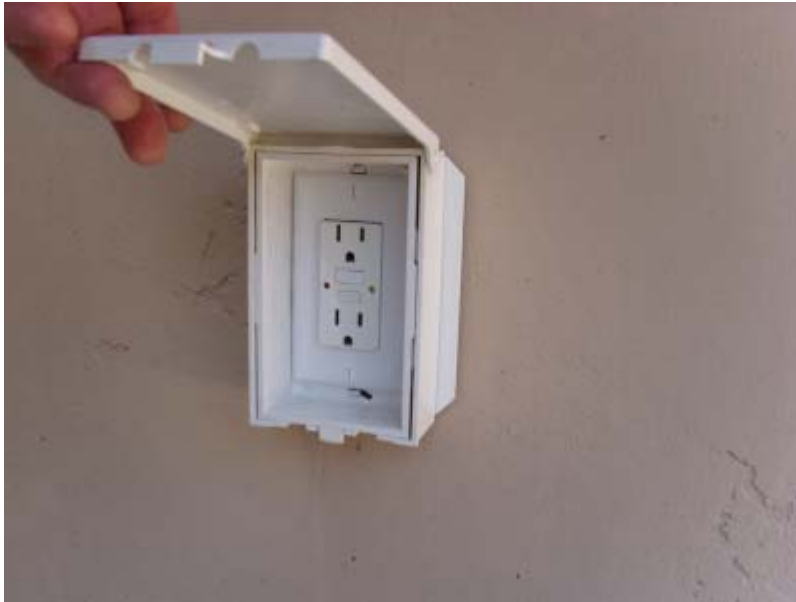
The GFCI receptacle at the upstairs front balcony did not trip when tested. We recommend it be repaired or replaced.

Faulty GFCI

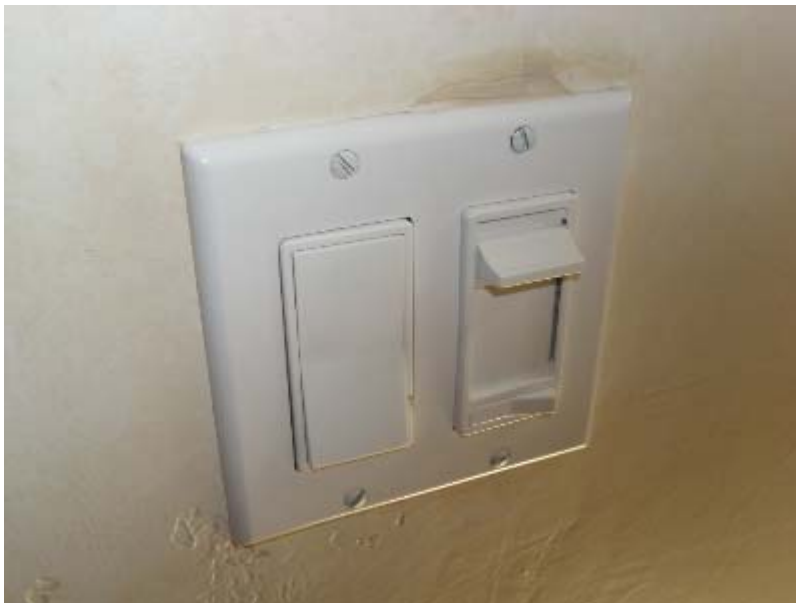
The entry area lights have a dimmer switch that is not functioning properly. We recommend the dimmer be replaced.

Faulty dimmer

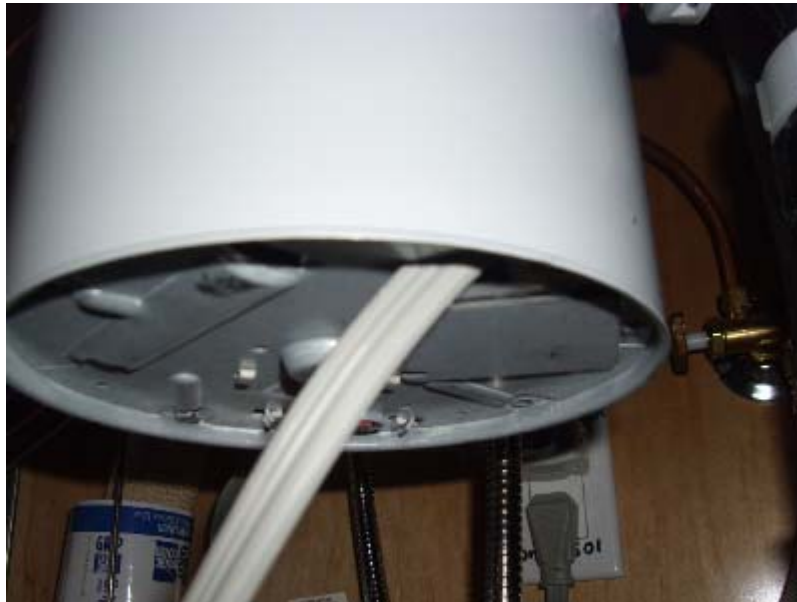
The power cord for the disposals are not secured where it enters the bottom of the disposal, and can be easily damaged. For maximum safety, we recommend the power cord be properly connected to the disposal.

No disposal cord clamps

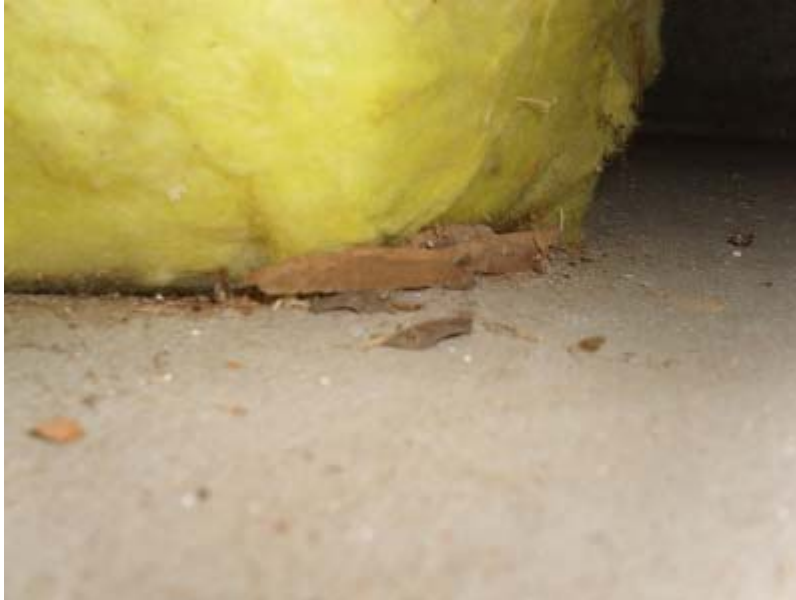
There is scrap wood on the soil in the crawl space. Cellulose debris can result in wood-destroying organism activity. We recommend the wood scrap be removed.

Cellulose debris

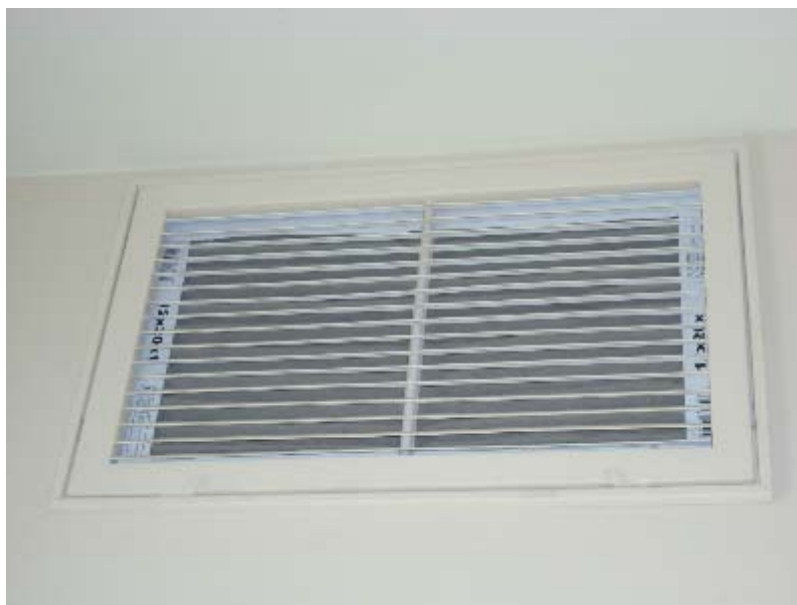
The filters have accumulated debris which decreases their effectiveness and blocks air flow. This can dramatically decrease the efficiency of the heating system. We recommend the filters be removed, cleaned and replaced if necessary.

Air filter replacement recommended

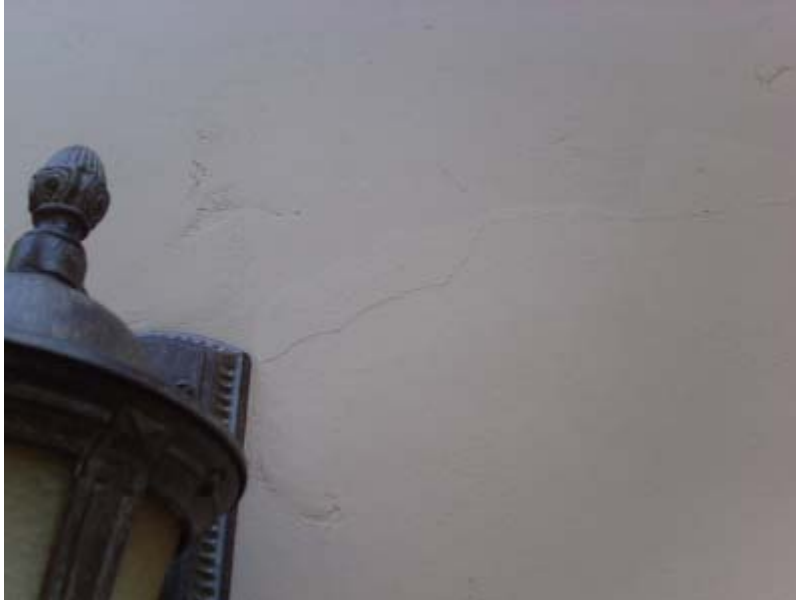
The stucco exterior is in good condition, with no significant cracks observed. Minor hairline cracks are typical and no action is indicated. They can be patched and sealed in the course of routine maintenance.

Small stucco cracks noted

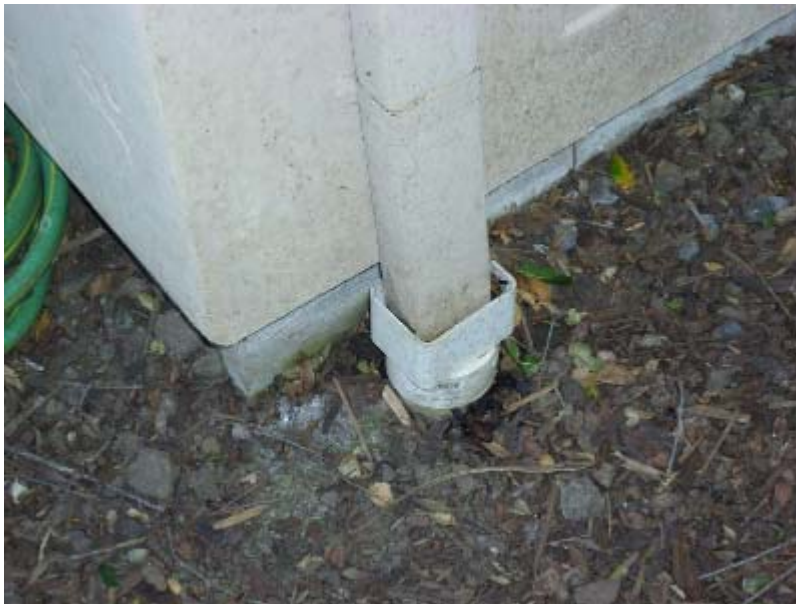
We observed some, but possibly not all, of the intake and discharge points for the drainage system. The property owner should identify and flag them for future reference.

The drainage system should be checked for debris and cleaned regularly to ensure proper operation during heavy weather.

Sub-surface drain system

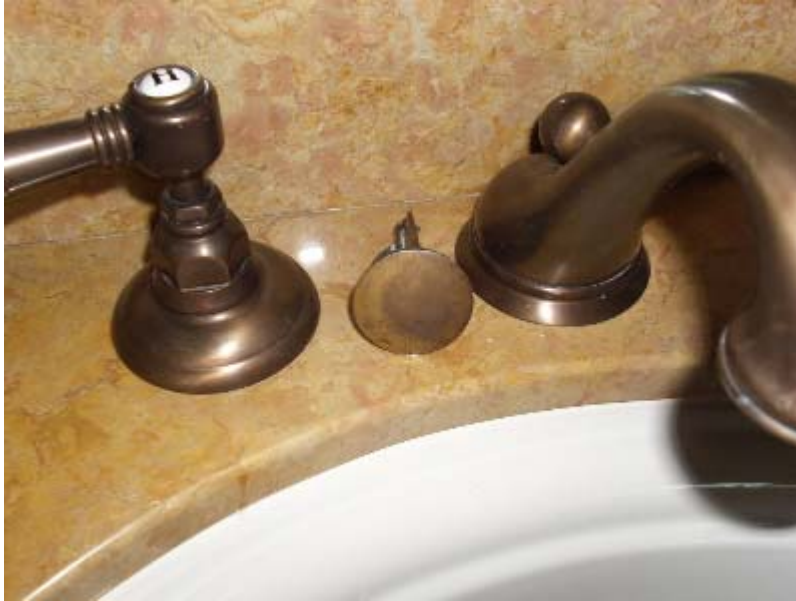
The drain stop is defective. We recommend it be repaired or replaced.

Drain stop needs repair

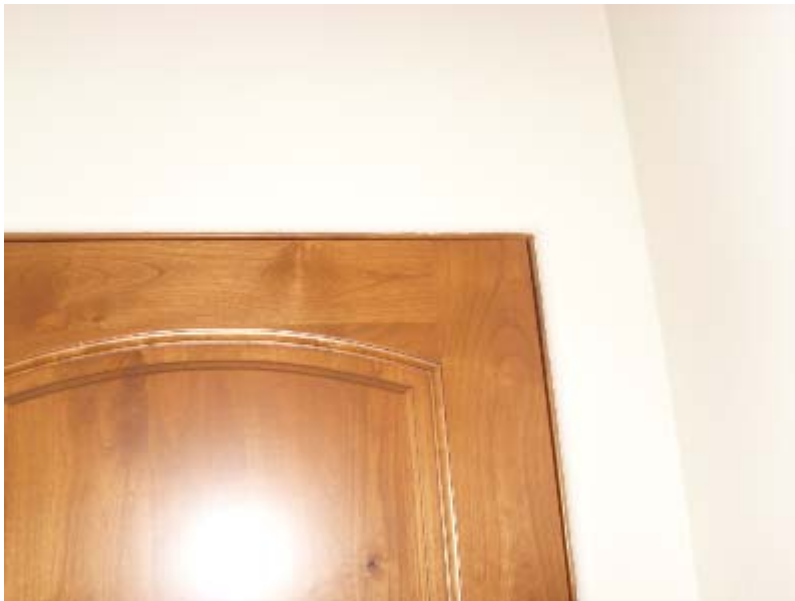
The bathroom door rubs on the frame. We recommend it be planed or sanded for smoother operation.

Sticking door

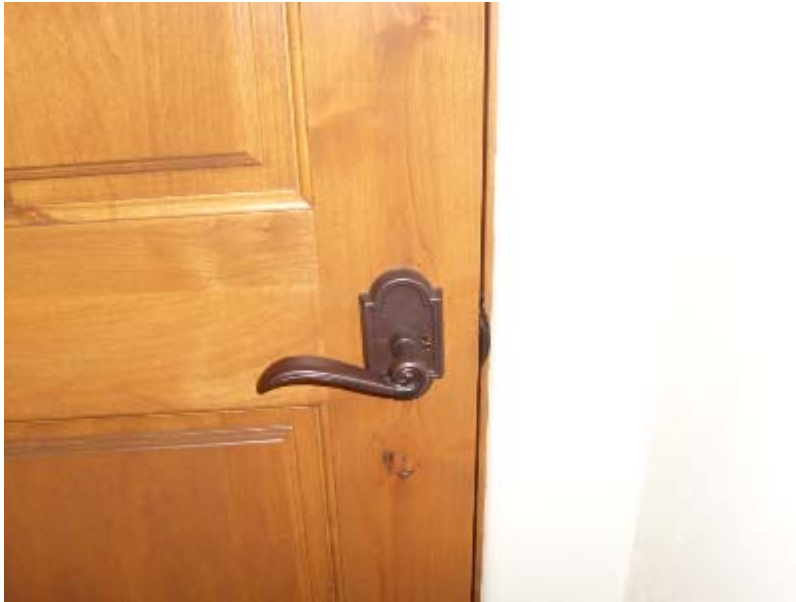
The door doesn't latch. We recommend adjustments to the hardware to restore proper function.

Door latch

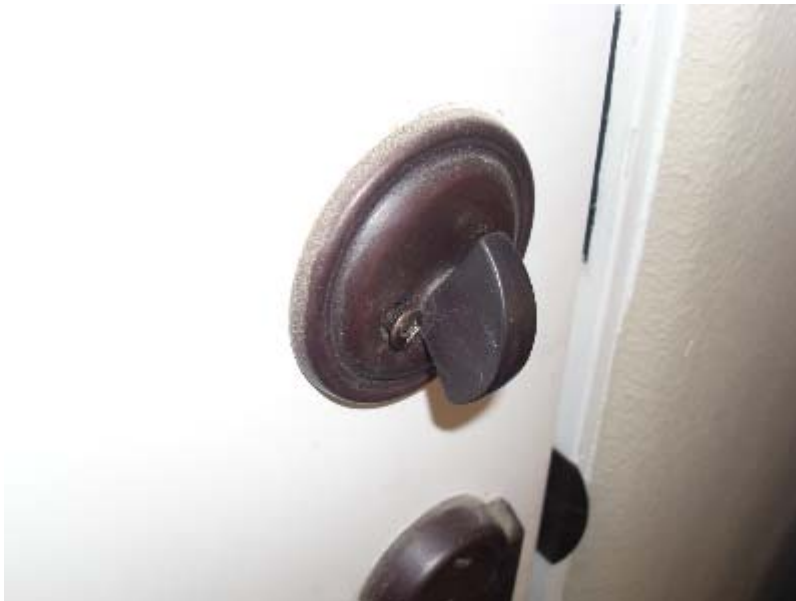
The lock on the side garage door does not operate properly. One of the screws holding it in place is stripped out. We recommend it be repaired.

Stripped deadbolt screw

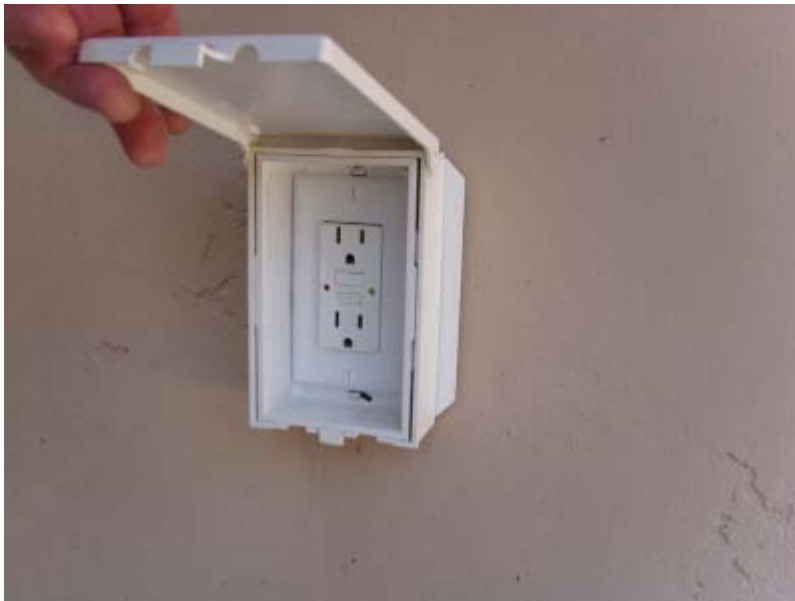
Item #1: - The GFCI receptacle at the upstairs front balcony did not trip when tested. We recommend it be repaired or replaced.

Faulty GFCI

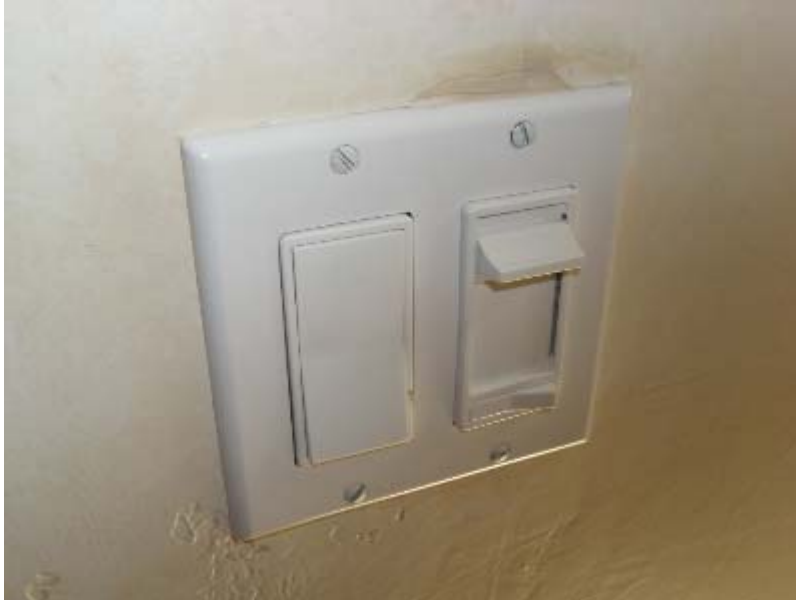
Item #2: - The entry area lights have a dimmer switch that is not functioning properly. We recommend the dimmer be replaced.

Faulty dimmer

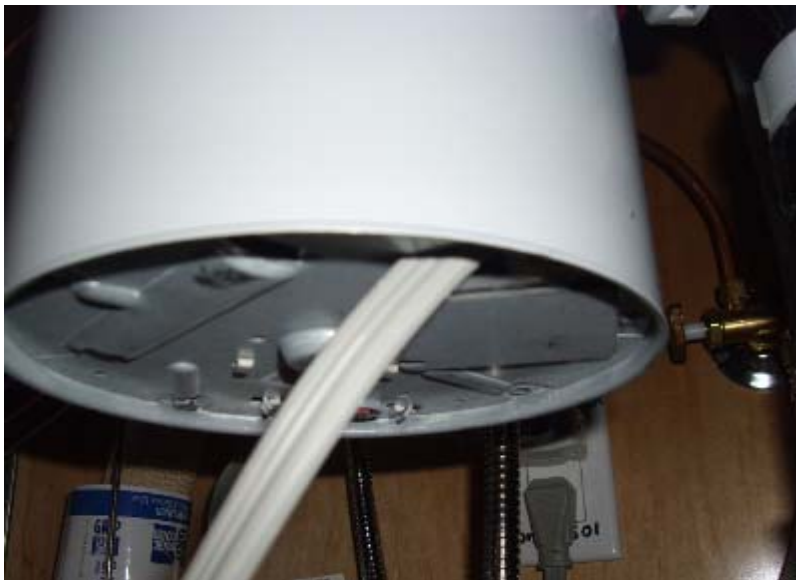
Item #3: - The power cord for the disposals are not secured where it enters the bottom of the disposal, and can be easily damaged. For maximum safety, we recommend the power cord be properly connected to the disposal.

No disposal cord clamps

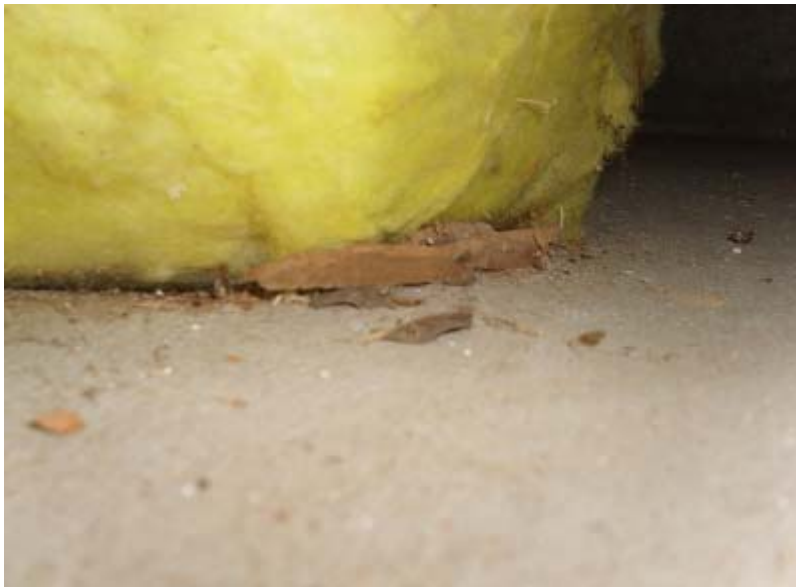
Item #5: - There is scrap wood on the soil in the crawl space. Cellulose debris can result in wood-destroying organism activity. We recommend the wood scrap be removed.

Cellulose debris

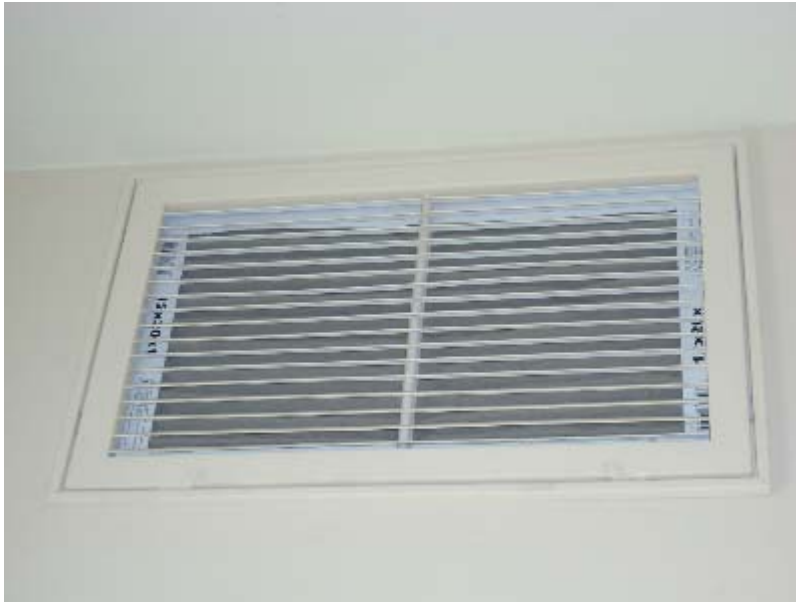
Item #6: - The filters have accumulated debris which decreases their effectiveness and blocks air flow. This can dramatically decrease the efficiency of the heating system. We recommend the filters be removed, cleaned and replaced if necessary.

Item #7: - There is no air filter for this heating unit at the cold air return in the kitchen area. We recommend a filter be installed to filter out dust, preventing its reentry into the occupied interior, and helping keep the blower and ductwork clean.

Air filter replacement recommended

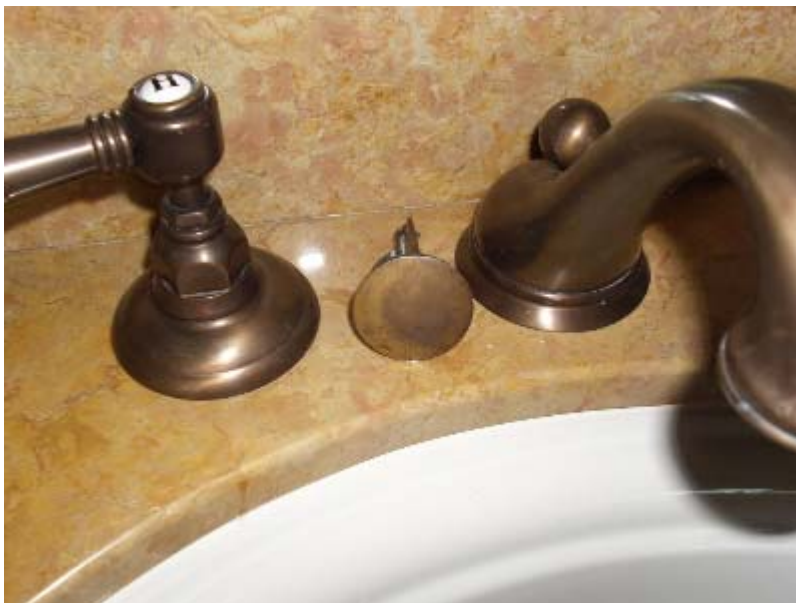
Item #8: - The drain stop is defective. We recommend it be repaired or replaced.

Drain stop needs repair

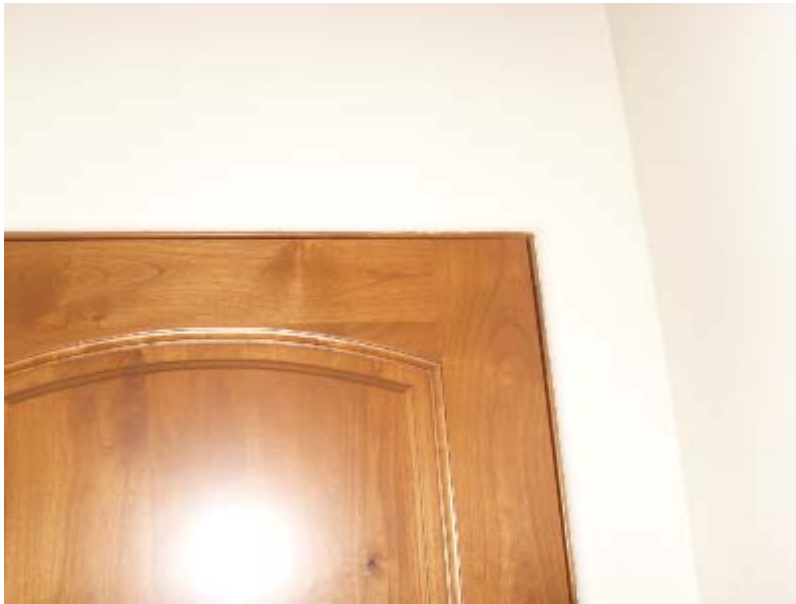
Item #9: - The bathroom door rubs on the frame. We recommend it be planed or sanded for smoother operation.

Sticking door

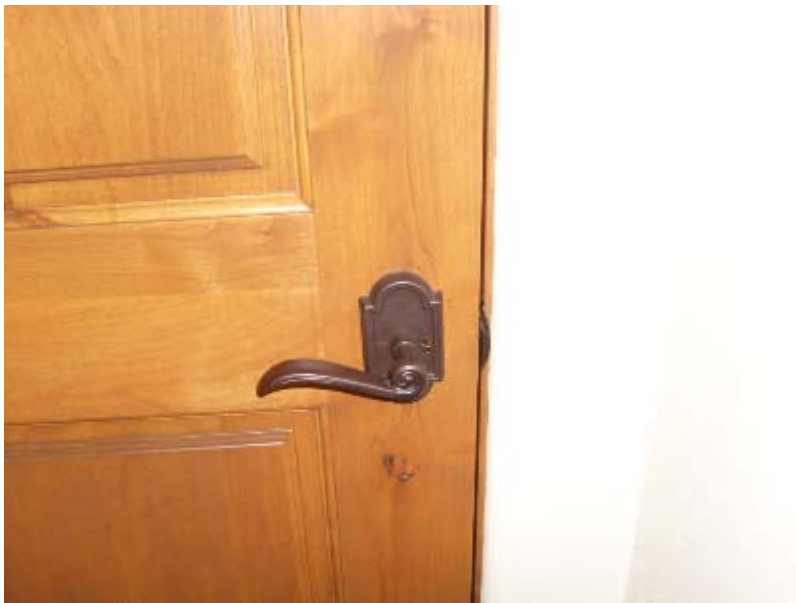
Item #10: - The door doesn't latch. We recommend adjustments to the hardware to restore proper function.

Door latch

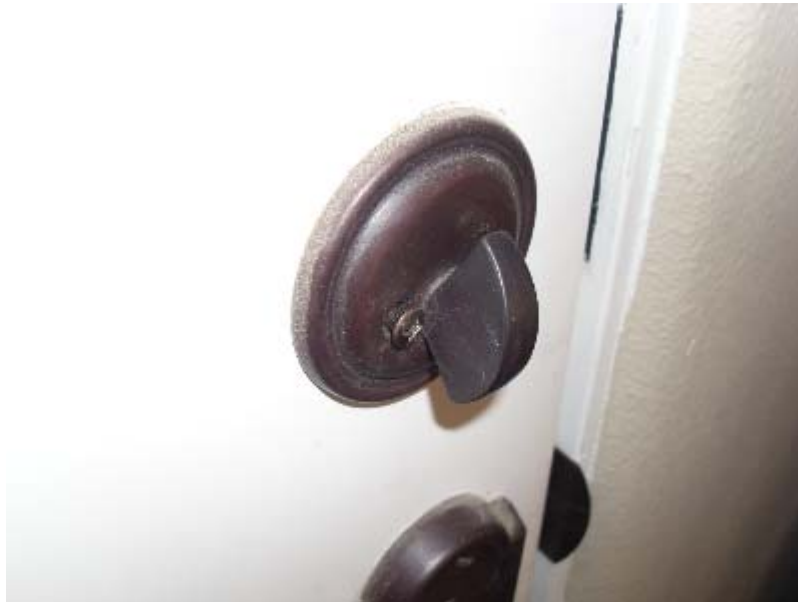
Item #12: - The lock on the side garage door does not operate properly. One of the screws holding it in place is stripped out. We recommend it be repaired.

Stripped deadbolt screw

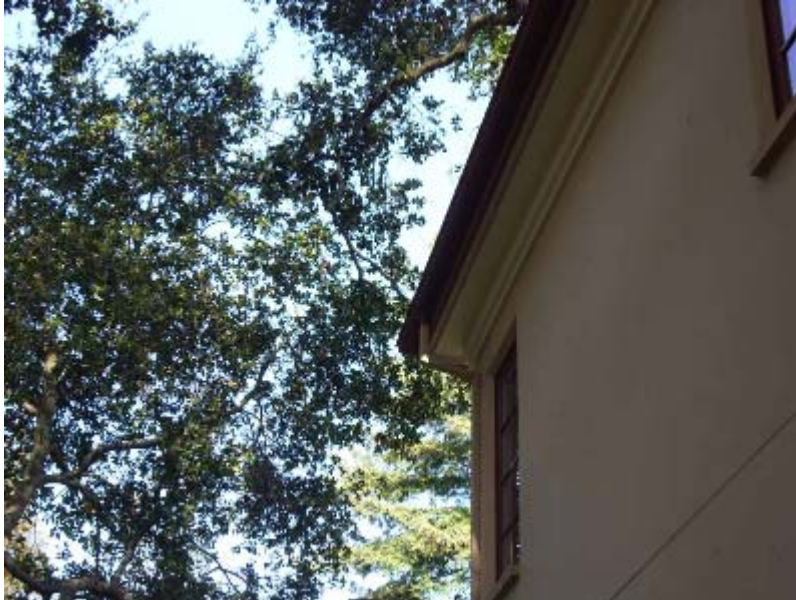
Item #14: - There are tree branches overhanging the roof in some areas. We recommend they be kept trimmed back to reduce the chance of damage to the roofing.

Overhanging branches
