WOOD DESTROYING PESTS AND ORGANISMS INSPECTION REPORT

| Building No. 10654 | Street N. Blaney Avenue | City Cupertino | Zip 95014 | Date of Inspection 04/10/08 | Page 1 of 8 |
| General Description: Two story townhouse, stucco siding, composition roof, crawl space, attached garage, occupied | | | | Inspection Tag Posted: Garage | |

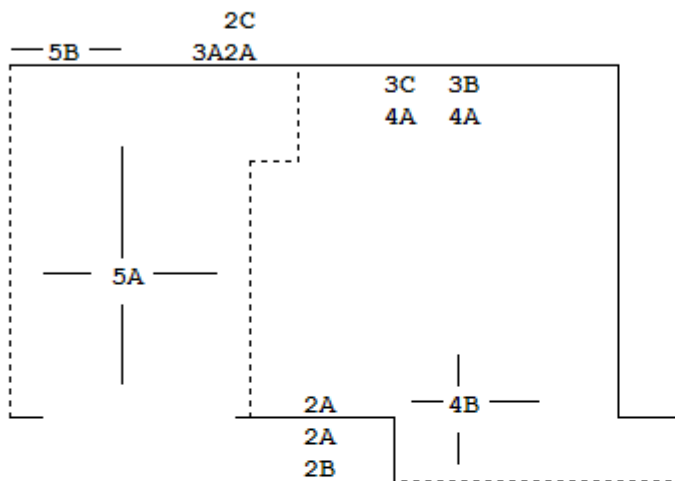
2A. FINDING: Evidence of drywood termites was found in the areas noted as 2A on the diagram.
RECOMMENDATION: Locally treat these areas for drywood termites with a registered termiticide. SECTION I ITEM.

2B. FINDING: Drywood termite damage was observed at the window trim, noted as 2B on the diagram.
RECOMMENDATION: REMOVE and REPLACE the damaged wood members. If possible, we will chisel or cut out damaged area and fill with either a plastic or wood filler. We will then sand and primer paint.

2C. FINDING: Drywood termite damage was observed at the garage side door trim, noted as 2C on the diagram.
RECOMMENDATION: REMOVE and REPLACE the damaged wood members. If possible, we will chisel or cut out damaged area and fill with either a plastic or wood filler. We will then sand and primer paint.
SECTION I ITEM.

3A. FINDING: Fungus damage was observed at the garage side door, noted as 3A on the diagram.
RECOMMENDATION: REMOVE and REPLACE the damaged wood members. If possible, we will chisel or cut out damaged area and fill with either a plastic or wood filler. We will then sand and primer paint.
SECTION I ITEM.
