Building Inspection Report

20632 Oak Creek Lane, Saratoga, CA

Inspection Date:
06/15/2009

Report Number:
200906151

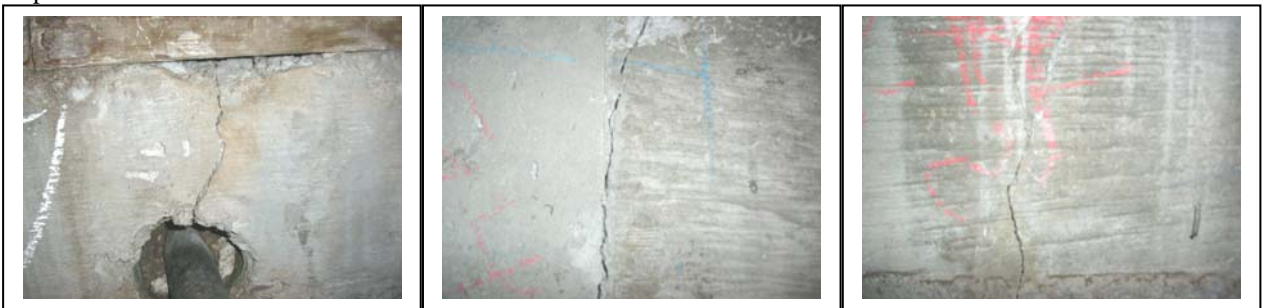
- **Monitor:** Larger than typical cracking (approximately 1/8" - 1/4") was observed in the foundation walls in the back of the house. The size of the cracks does not suggest a serious problem at present, but this area should be monitored. If additional movement occurs, repairs might be necessary. The rate of movement cannot be predicted during a one-time inspection.

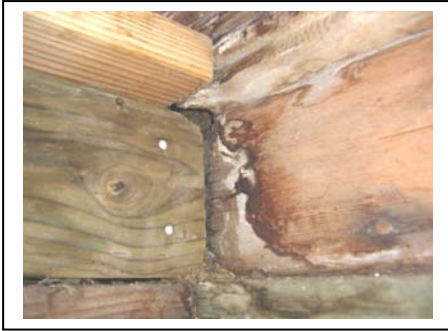
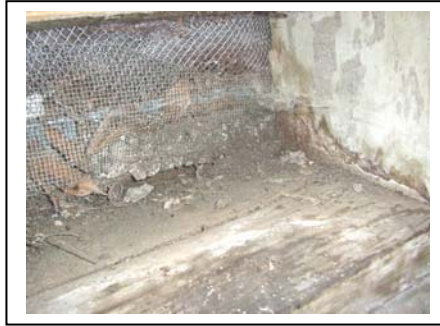
- **Repair:** Evidence of moisture damage was observed on the floor framing at the rim joist on the right side of the house and vent frame in the back of the house. Damaged wood should be repaired or replaced as necessary and the conditions that have promoted the damage should be remedied. A qualified licensed pest control contractor should be consulted for further evaluation and correction.

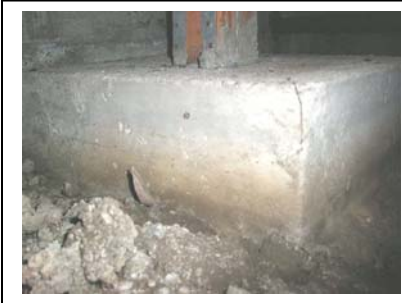
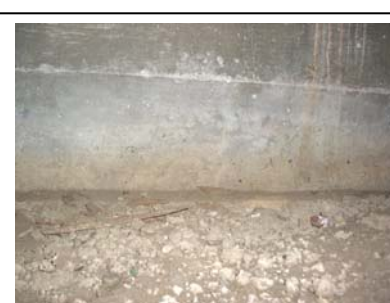
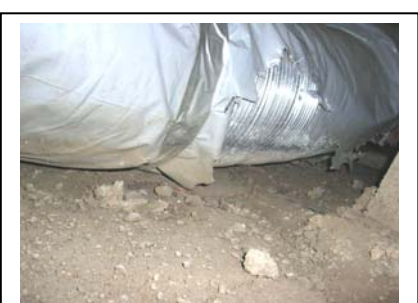
- Repair:** The soil was relatively dry at the time of the inspection; however, silt marks on the foundation and/or other vertical features were indications that standing water had collected in the crawl space in the back of the house. Wet crawl spaces risk building damage from rot and can cause interior mold or mildew and rusting of mechanical component. This condition may vary seasonally and/or with precipitation intensity. Roof and lot drainage repairs or improvements should be addressed as a first step to controlling water in the crawl space (see "Exterior"). This condition should then be monitored to determine if additional measures are necessary to protect the dwelling crawl space from water.

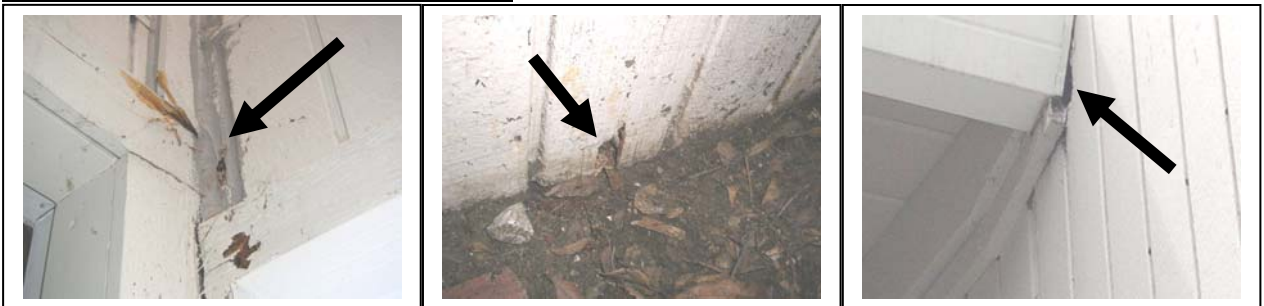
- **Repair:** Evidence of moisture damage was observed in the siding in the front, back and right side of the house. All damaged siding should be repaired or replaced as necessary. A qualified licensed pest control contractor should be consulted for further evaluation and correction.

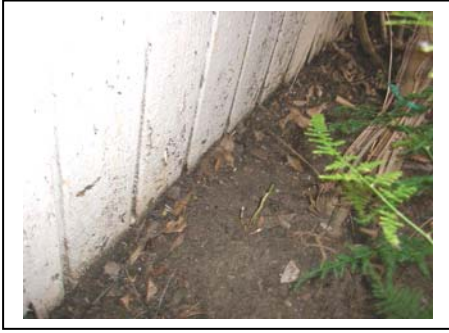
-
-
- **Repair:** Wood/soil contact at the base of the siding in the back of the house should be eliminated. We recommend elimination of all earth/wood contact to reduce the potential for wood destroying organism infestation and damage to

wooden building elements. A clearance of six inches or more is suggested between wooden building elements and the soil. Any damaged material discovered in the course of this work should be repaired or replaced as necessary.

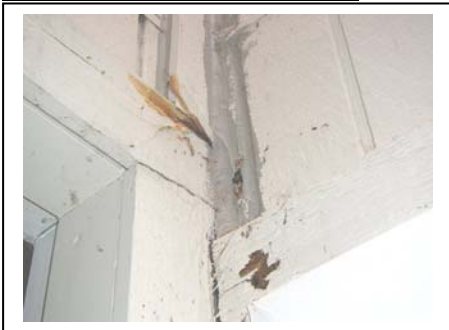
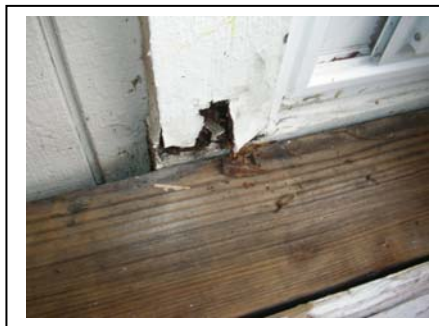
- **Repair:** Evidence of moisture damage was observed in the trim in the back and right side of the house. All damaged trim should be repaired or replaced as necessary. A qualified licensed pest control contractor should be consulted for further evaluation and correction.

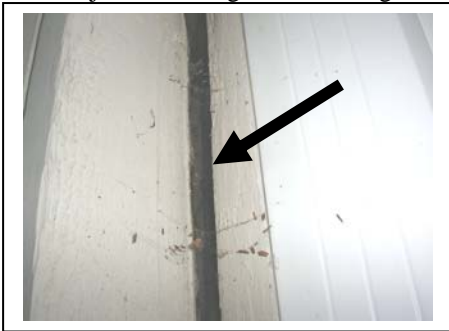
- **Improve:** The trim is missing on the right side of the house. For improved appearance and maximum protection of the exterior joints and edges, all missing exterior trim should be replaced.

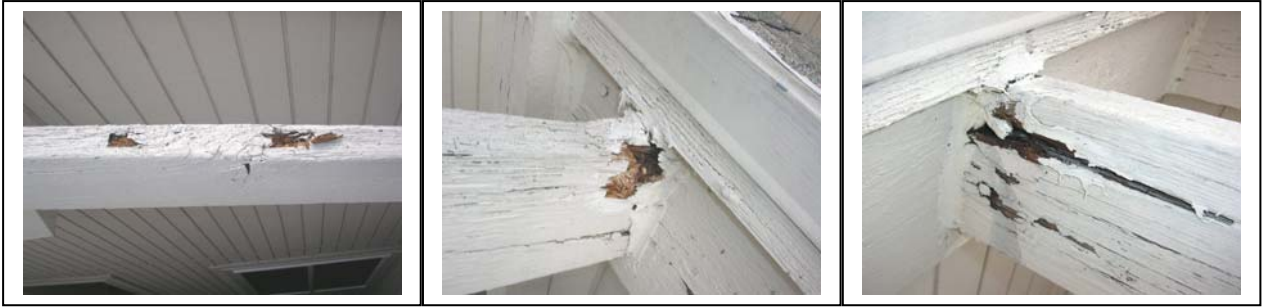
- **Repair:** Evidence of moisture damage was observed in the rafter on the right side of the house. The damaged sections of rafter tail should be repaired or replaced as necessary. A qualified licensed pest control contractor should be consulted for further evaluation and correction.

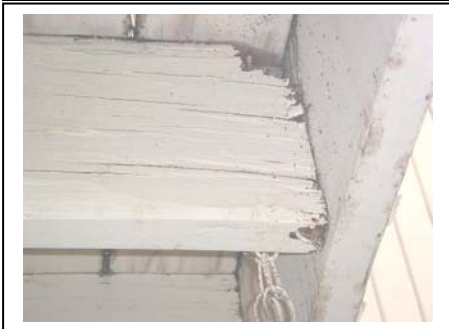
- **Repair:** Portions of the deck in the back of the house shows evidence of moisture damage. All damaged materials should be removed and replaced with material treated to resist wood destroying organisms. A qualified licensed pest control contractor should be consulted for further evaluation and correction.

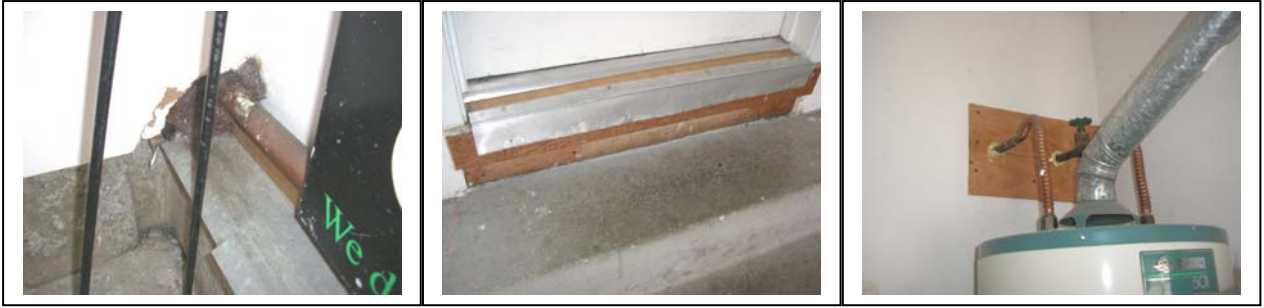
- **Repair:** Wall and ceiling finishes of attached garages should be repaired where they abut the interior of the house. Any damaged or missing sections of wall or ceiling, including openings around pipes, vents or any other wall or ceiling penetrations, should be repaired or replaced as necessary and all seams between sections of drywall should be properly covered with tape and texture. These walls and ceilings serve as a firebreak and reduce the potential of toxic automobile gasses entering the house.

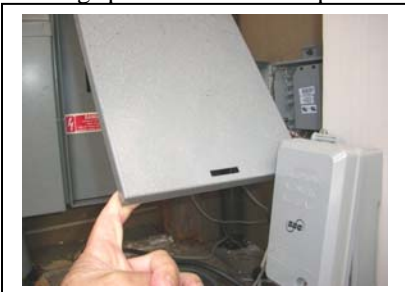
- **Improve:** Screw(s) were missing from the panel cover. Special blunt-end screw(s), made especially for this purpose, should be installed to secure the cover and ensure that no damage is done to wiring in the panel when the screw is installed.
- **Improve:** The main panel is obstructed and not easily accessible, if at all. There should be at least three (3) feet of working space in front of the panel. Landscaping or other obstructions should be kept clear of this area.

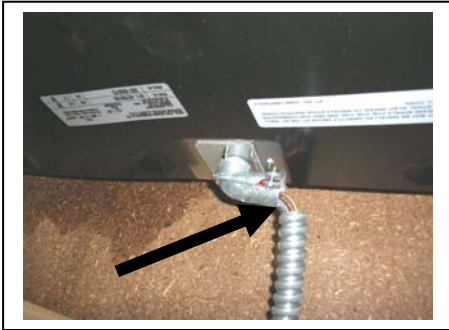
- **Improve:** The conduit under the kitchen cooktop had parted at a joint, leaving wiring exposed to damage. This conduit should be repaired to reduce any potential hazards.

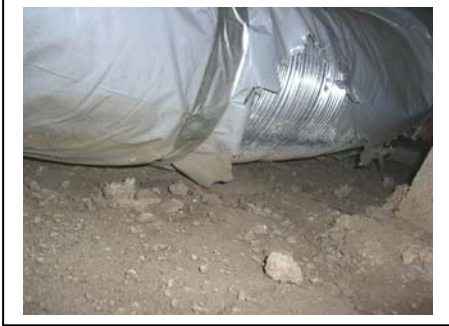
- **Improve:** The ductwork was in contact with the ground in the back of the crawl space. This is conducive to corrosion and damage and may affect the performance of the heating and cooling system. A minimum of 4" of clearance from the soil should be created and maintained by adding additional supports where needed.

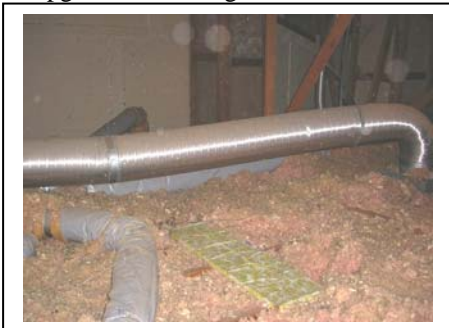
- **Improve:** The depth of insulation above the living spaces was inadequate by present building standards. Adding insulation to increase the thermal resistance of this area would be a very cost-effective step in enhancing the energy efficiency of the dwelling.
- **Improve:** The skylight well was not insulated. Adding insulation to the skylight well would increase the thermal resistance of this area.
- **Improve:** The cold air return duct was not insulated. This can decrease energy efficiency and increase energy costs. As an upgrade, insulating the ducts in accordance with present standards could be considered.

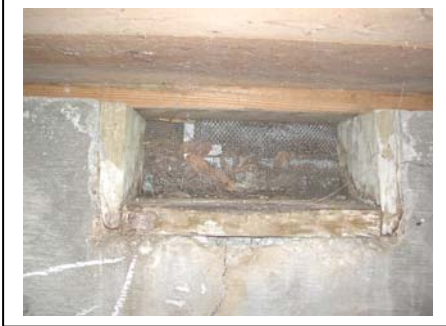
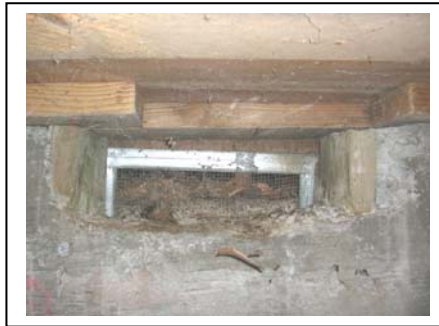
- **Repair:** The level of crawl space ventilation is insufficient. It is generally recommended that one (1) square foot of free vent area be provided for every one hundred and fifty (150) square feet of crawl space. The vents should be spaced evenly and provided on all sides of the dwelling, if possible, to provide adequate cross ventilation and promote air movement. Proper ventilation will help to control humidity and reduce the potential for rot. We recommend that vents be added on the right side of the house.
- **Repair:** Obstructed crawl space wall vents in the back of the house should be cleared or opened to ensure adequate ventilation of the critical underbuilding area.

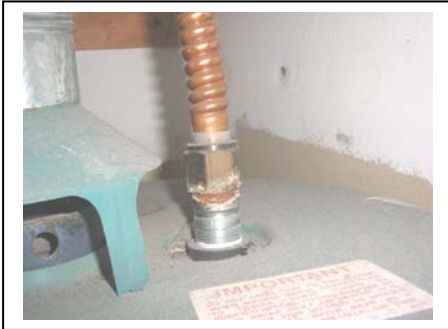
- **Monitor:** The water connections on the water heater were corroded but no leakage was apparent. These connections should be monitored for leakage and repaired or replaced if necessary.

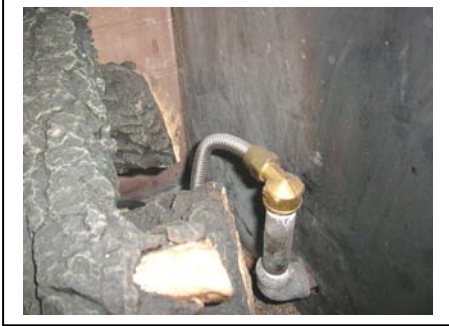
- **Monitor:** There is a flexible gas line located inside the factory built fireplace. Under these conditions, the fireplace can only be used as a gas fireplace. In order to be used as a wood burning fireplace, as originally designed, the flexible gas line will need to be removed from the inside the fireplace and replaced with gas piping approved for this application.
